Rimkus Consulting Group, Inc.
Eight Greenway Plaza, Suite 500
Houston, TX 77046
(800) 580-3228 Telephone
(713) 623-4357 Facsimile

Re: RCG File No: 11009971
LLV Number: 0209452
VMF Location: 1530 Greensmark Drive in Houston, Texas
Subject: Final Report

Rimkus Consulting Group, Inc. was retained to examine LLV 0209452, VIN 1GBCS10E4M2908832. The fire occurred on June 13, 2016 at around 12:30 P.M. the operator of the vehicle at the time of the fire, was unavailable for interview but reportedly stated the vehicle's engine died while delivering mail on his route and backfired during subsequent attempts to restart it. Soon thereafter, smoke was observed from beneath the hood as well as flames.

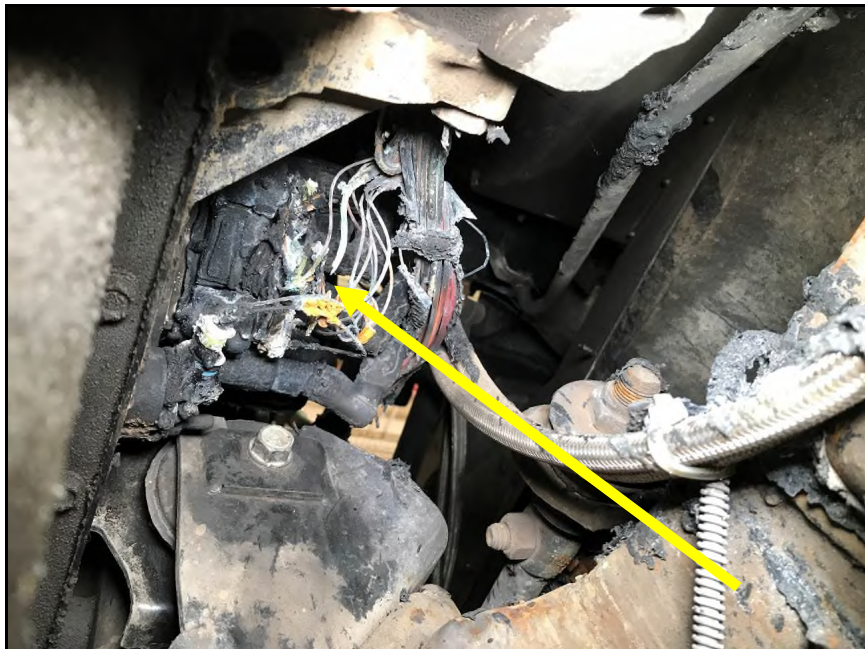
Photograph 4

View of failed ignition module and coil from beneath undercarriage.

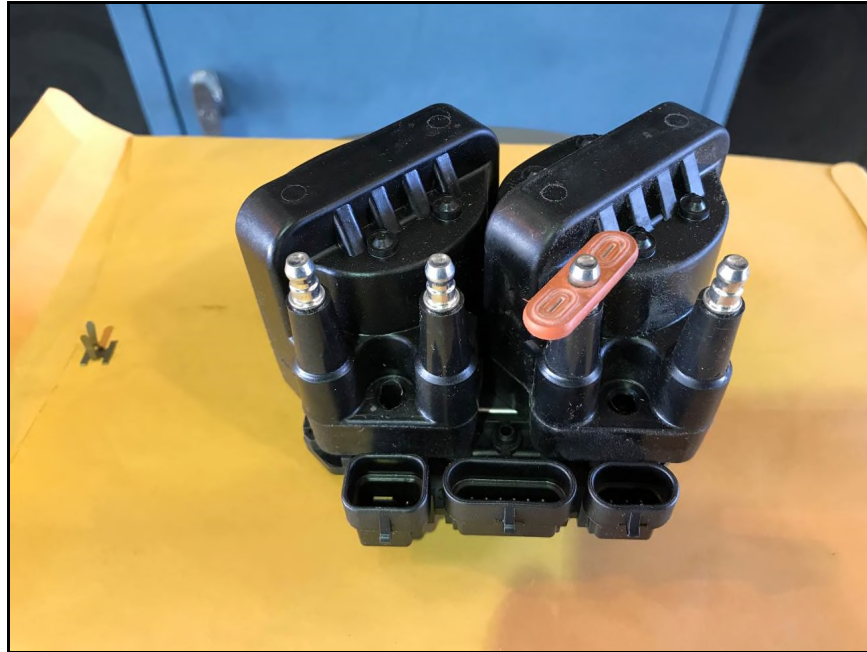
Photograph 5

Exemplar ignition module and coil. The module was identified as manufactured by ACDelco, P/N 19178833, C/N 01406682656.

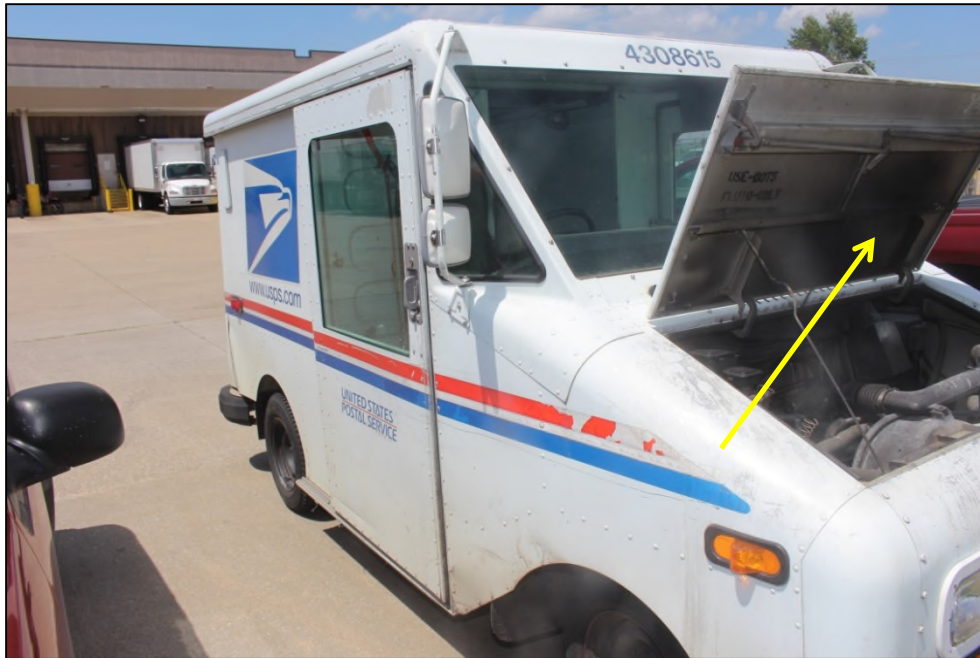
Photograph 3

Driver's side of the vehicle, observe the smoke damage to the hood area.

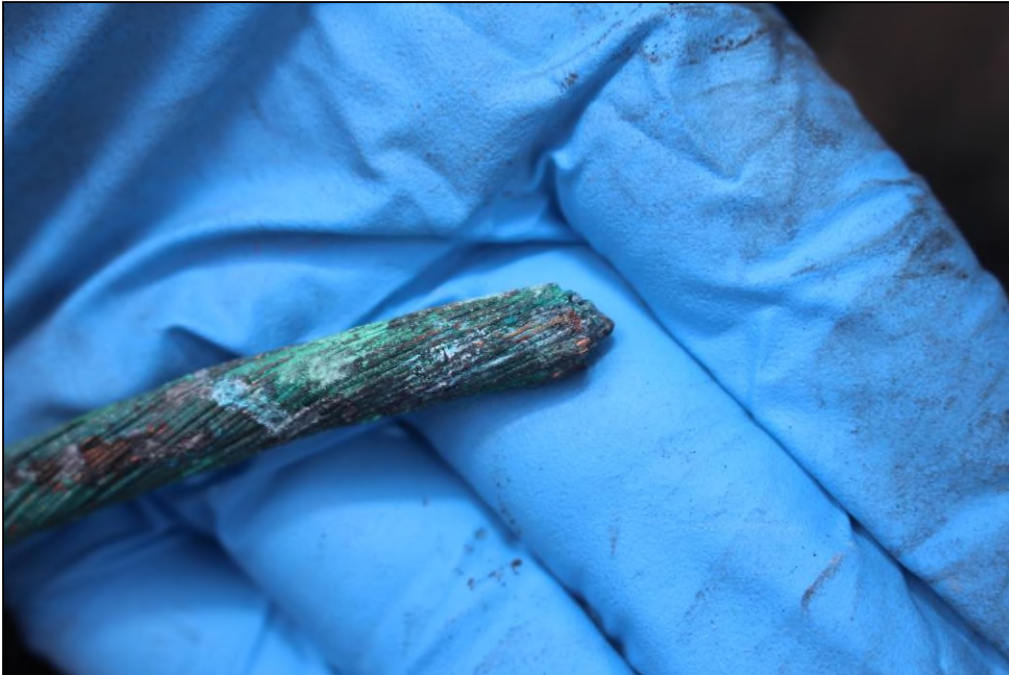
Photograph 7

End of battery cable from the battery.

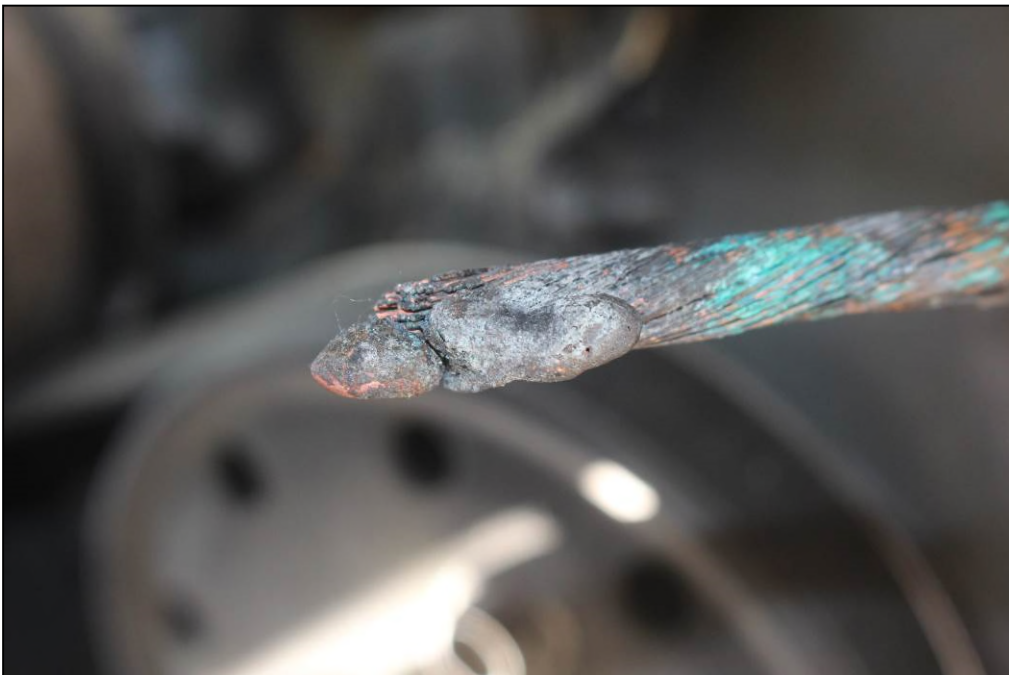
Photograph 8

View of the electric cable downstream from the retaining ring.

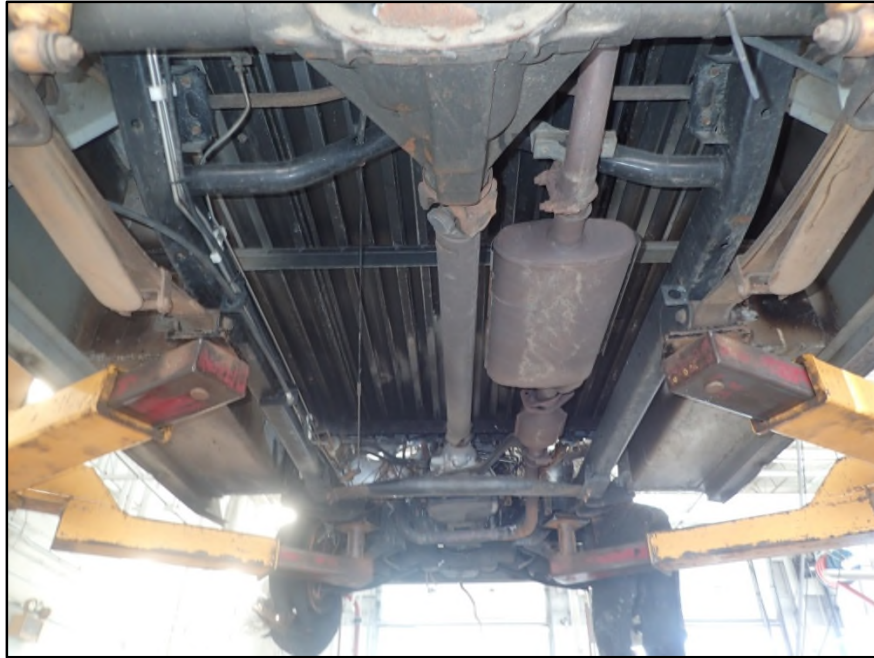
Photograph 7
Undercarriage of LLV.

The undercarriage of the vehicle was examined and was unremarkable with the exception of the area under the engine compartment. Fuel lines on the undercarriage were intact along the frame rail. The LLV was mounted on a GM general frame and was undamaged. The fuel tank and fuel lines did not show any signs of failure. The exhaust system was intact and undamaged.

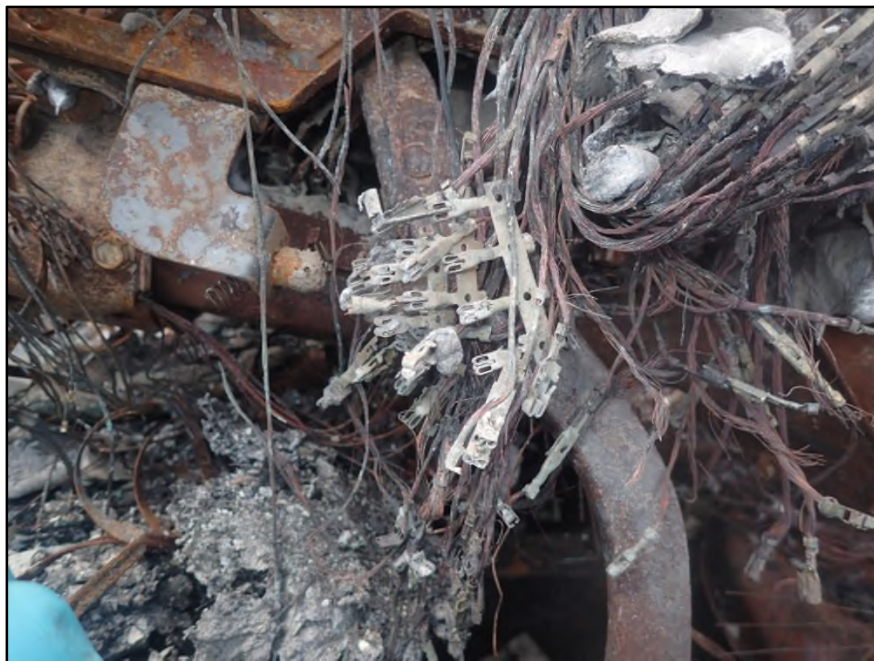
Photograph 8
Conductors and remains of fuse panel.

The fuse panel was positioned below the instrument panel in the dashboard on the driver's side and was significantly damaged by fire.

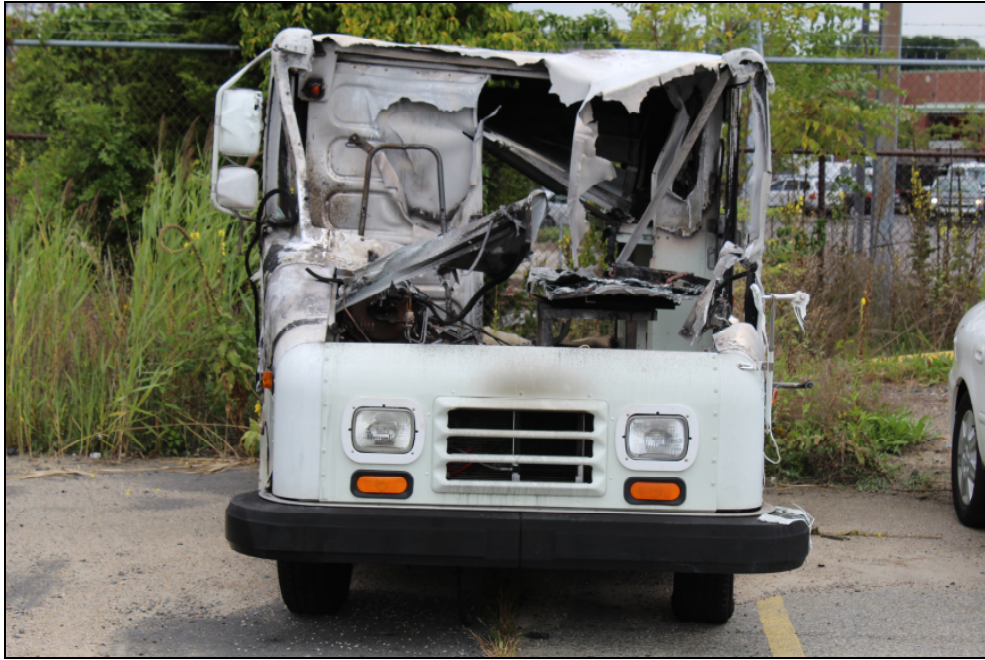
Photograph 1
View of the front.

The exterior examination of the vehicle began at the front exterior and continued in a counter-clockwise direction. The hood, windshield and driver's compartment roof were extensively damaged and melted, the driver's side evidenced fire damage in the engine compartment and driver's compartment. The rear of the vehicle suffered minor fire damage to the cargo area. The mail side of the vehicle evidenced significant fire damage in the engine compartment and driver's compartment.

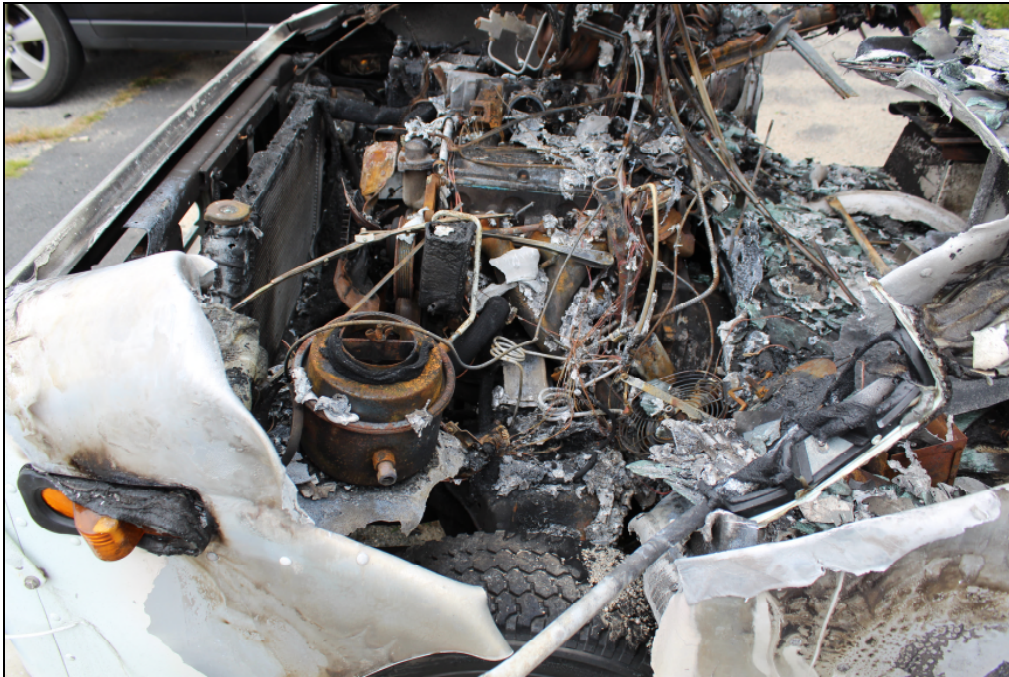
Photograph 5

1. Fire originated within the engine compartment while being operated.
2. The specific ignition sequence was inconclusive; however, a catastrophic internal failure of the engine could not be eliminated.

View of the area of origin on the mail side of the engine compartment.

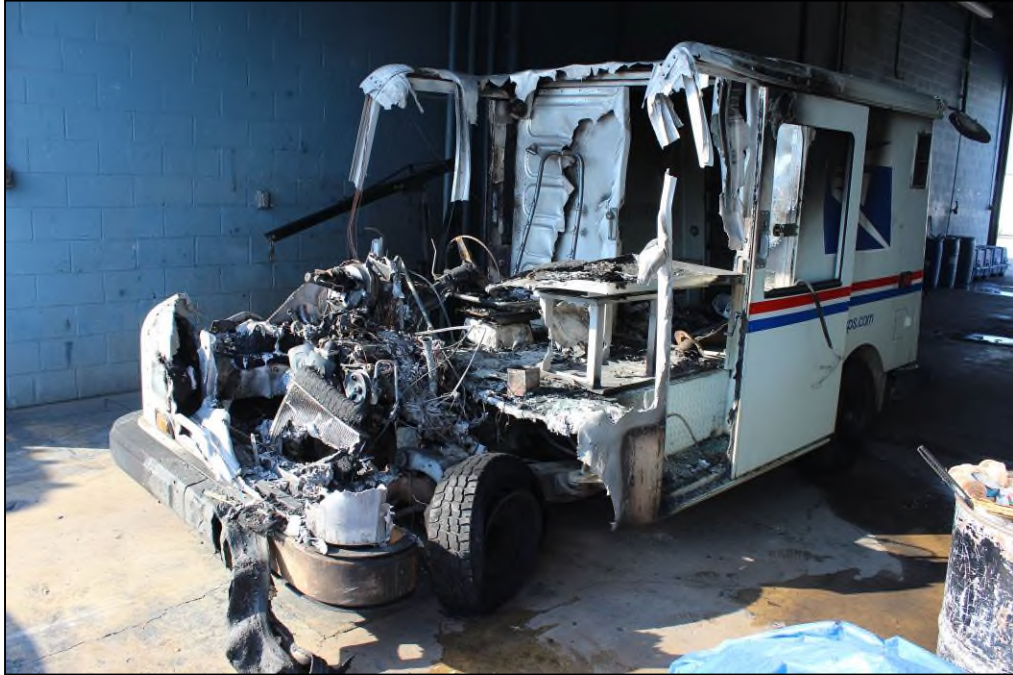
Photograph 1

LLV 4308983, the vehicle was examined at the USPS VMF located at 685 South Third Street in Memphis Tennessee.

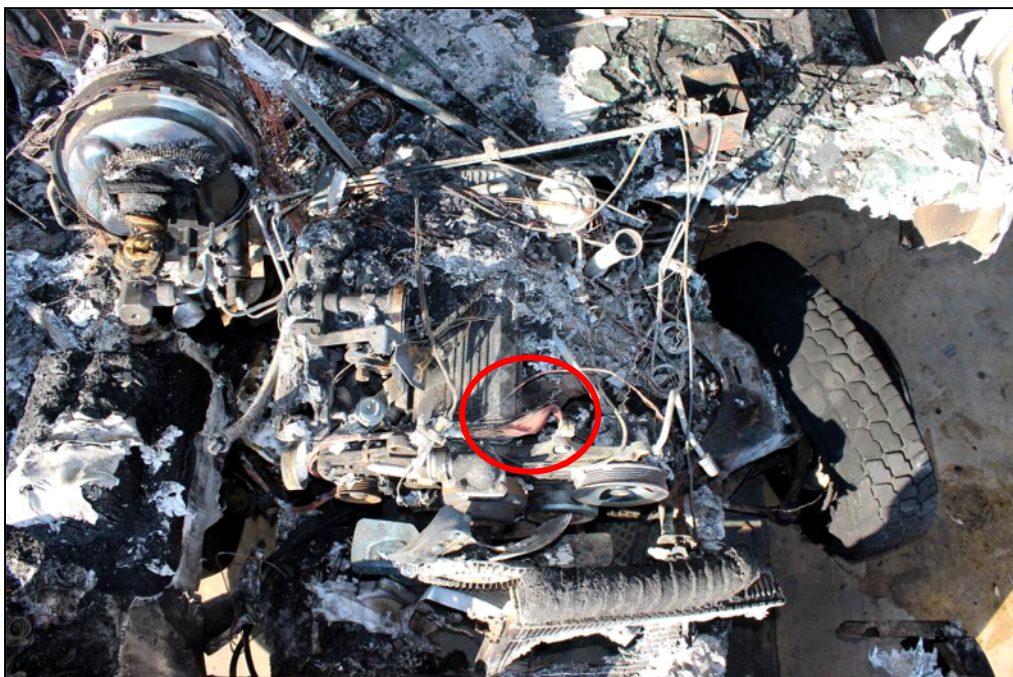
Photograph 2

Overhead view of the engine compartment from the front bumper, the circle indicates the area of origin.

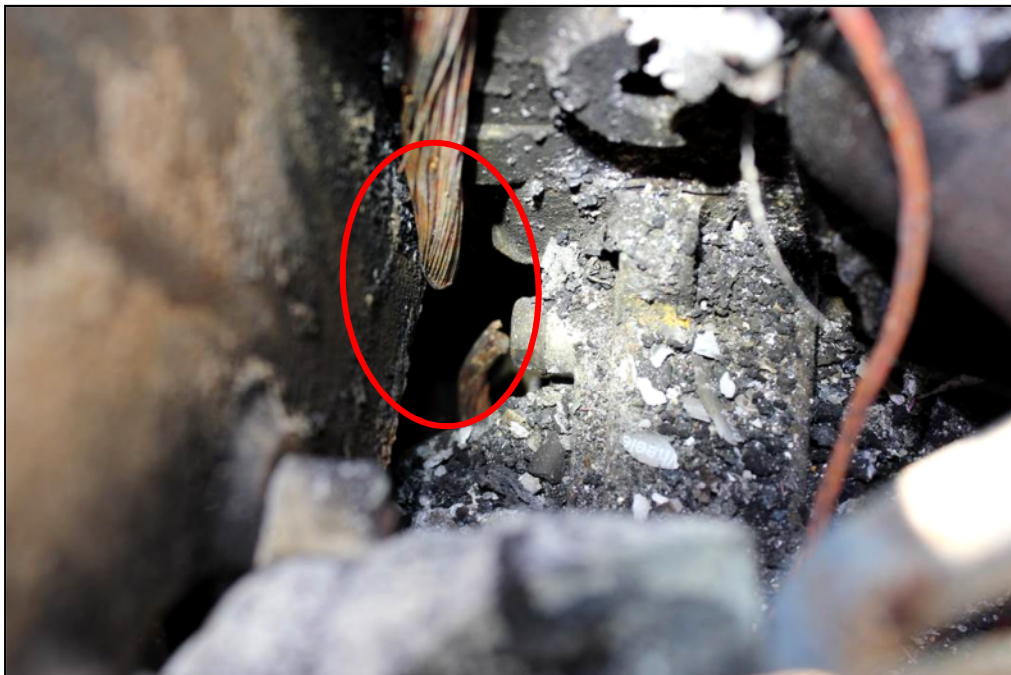
Photograph 4

The positive battery conductor was observed severed due to adverse electrical activity. The plastic insulation was damaged in this area due to not being supported away from the sharp metal edges.

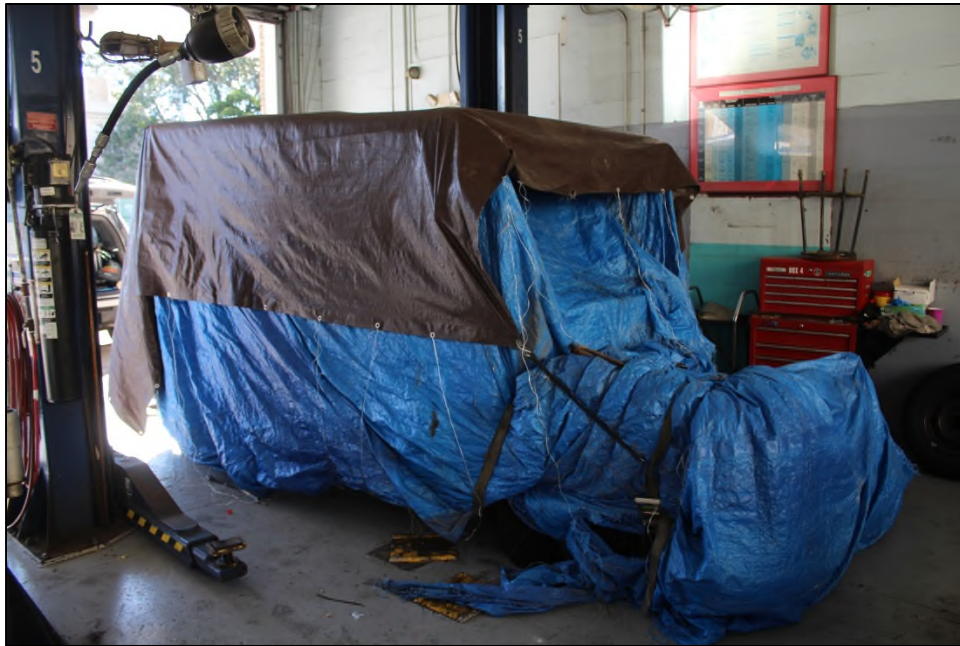
Photograph 1

The fire-damaged vehicle was completely wrapped and preserved prior to our inspection.

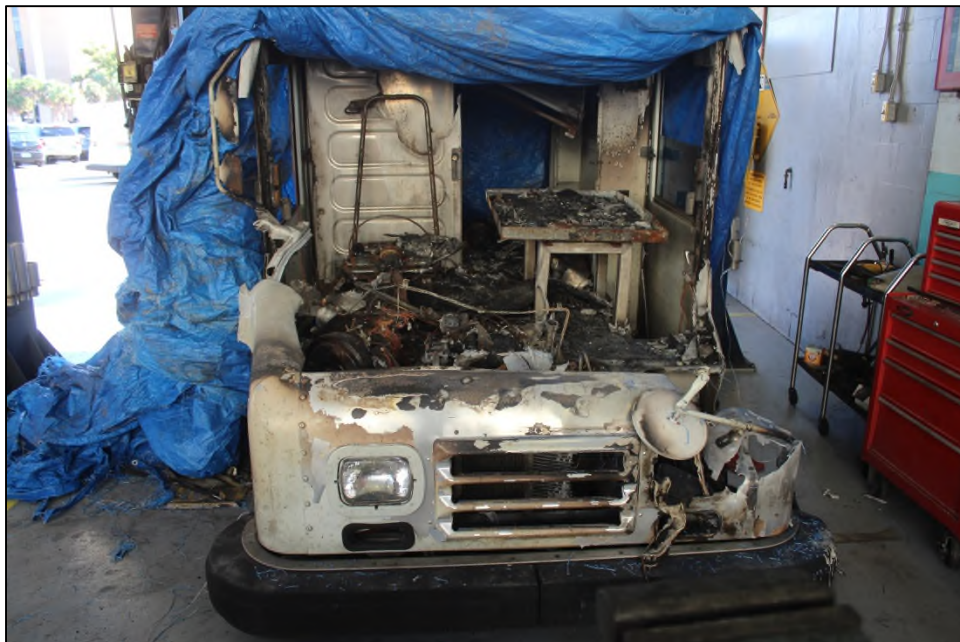
Photograph 2

Front view of fire-damaged LLV 4309372.

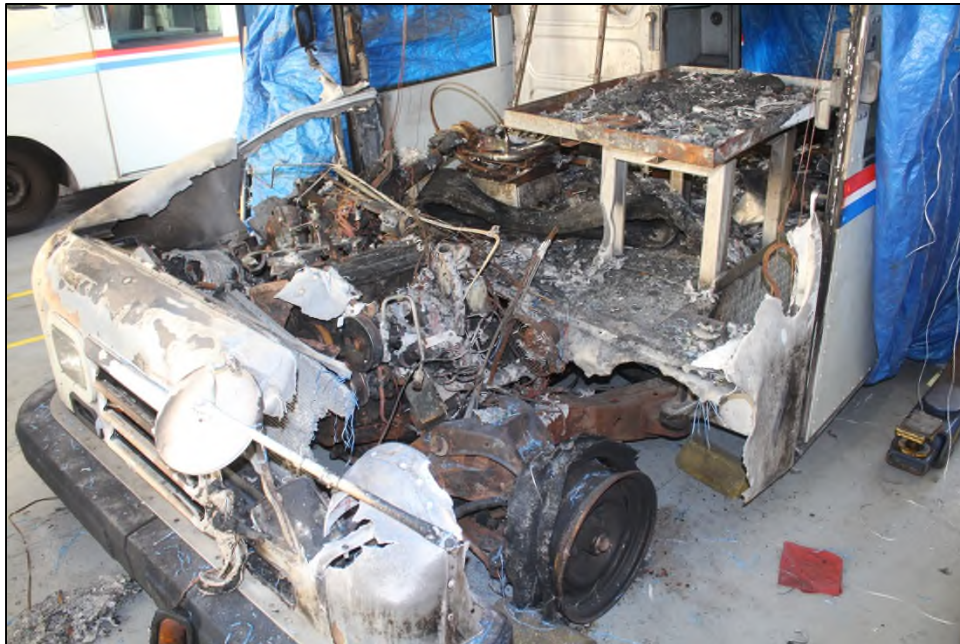
Photograph 3

The front left side of the vehicle sustained greater damage as compared with the front right side.

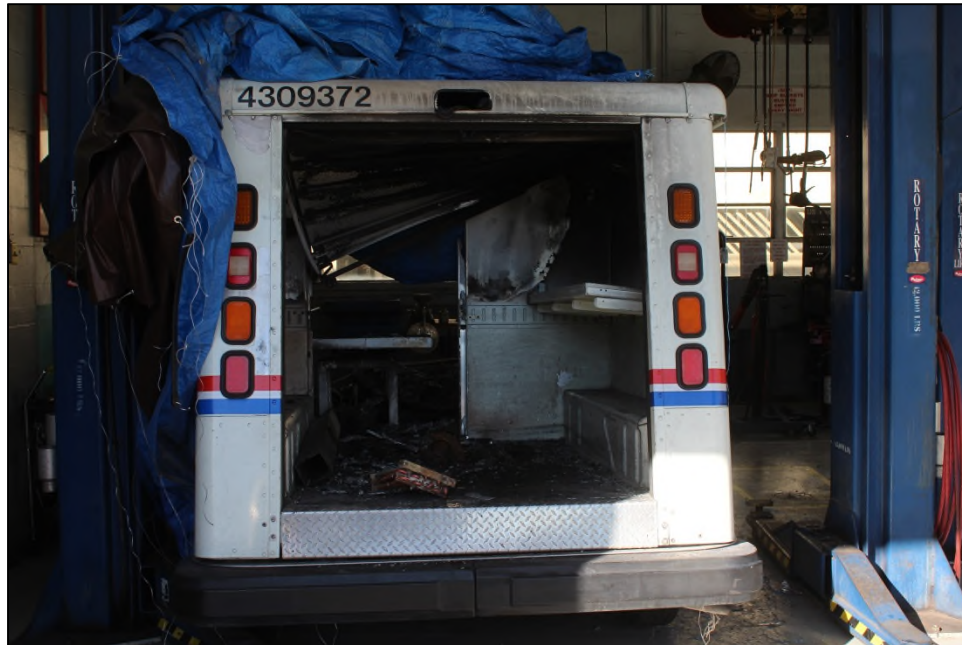
Photograph 5

Rear view of the fire-damaged postal vehicle.

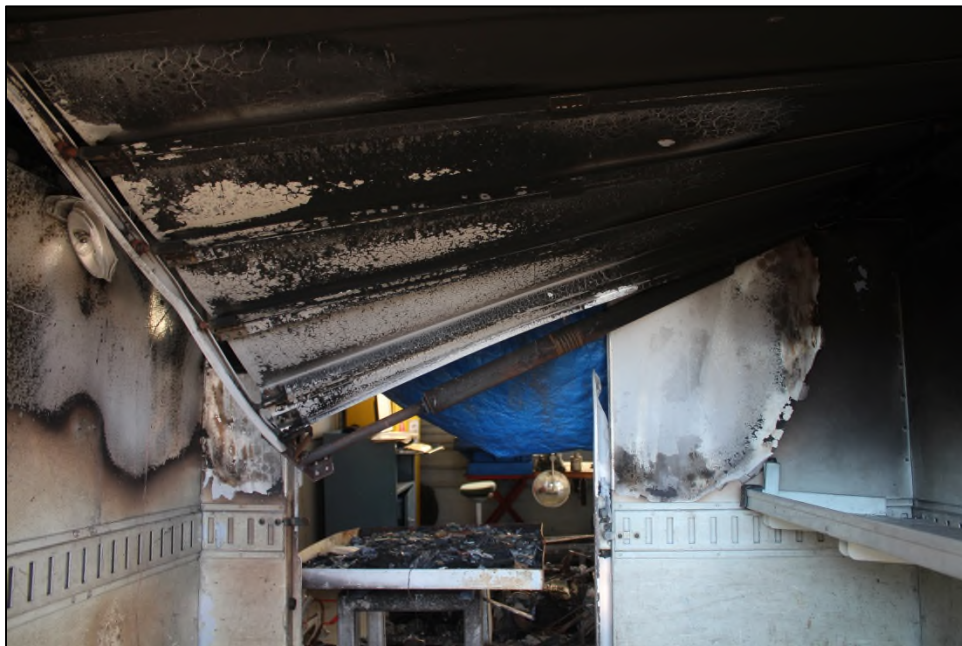
Photograph 6

View of the cargo space.

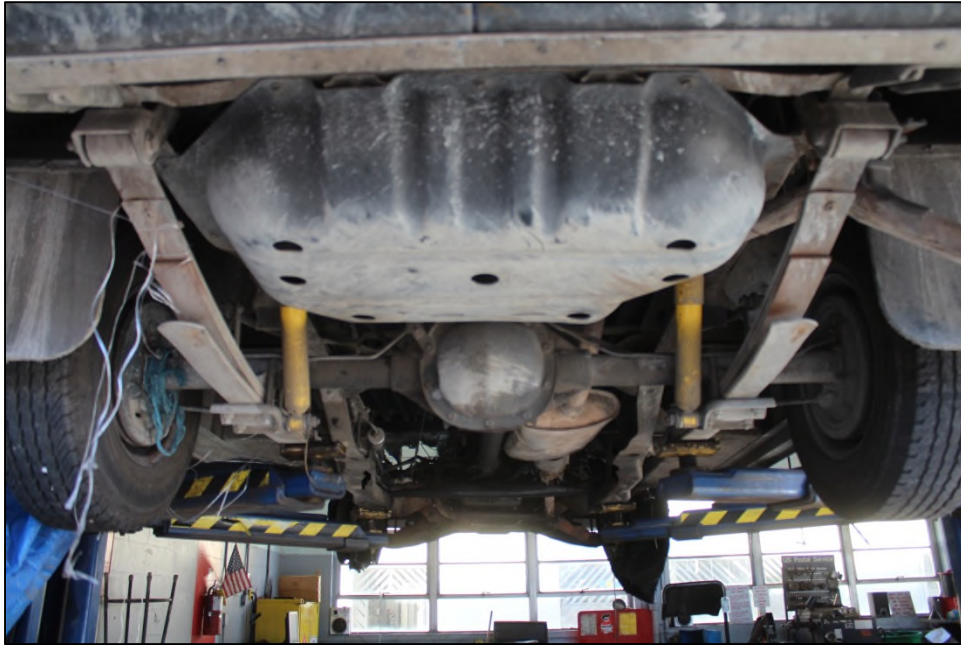
Photograph 7

View of the undercarriage from the rear of the vehicle.

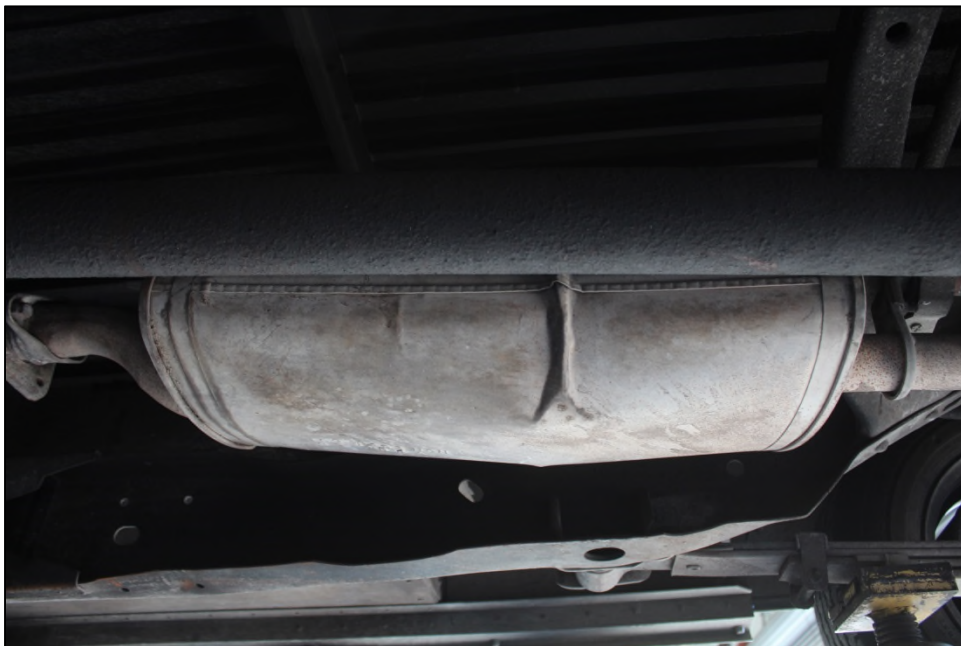
Photograph 8

The muffler look like it had expanded from a possible backfire.

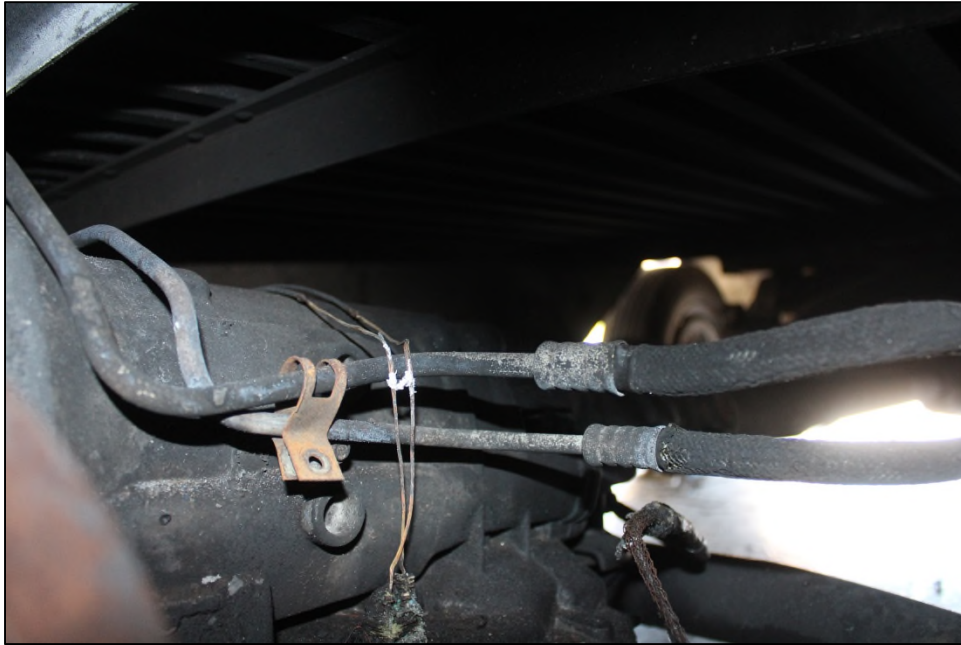
Photograph 9

The fuel line appeared to be slightly dislodged.

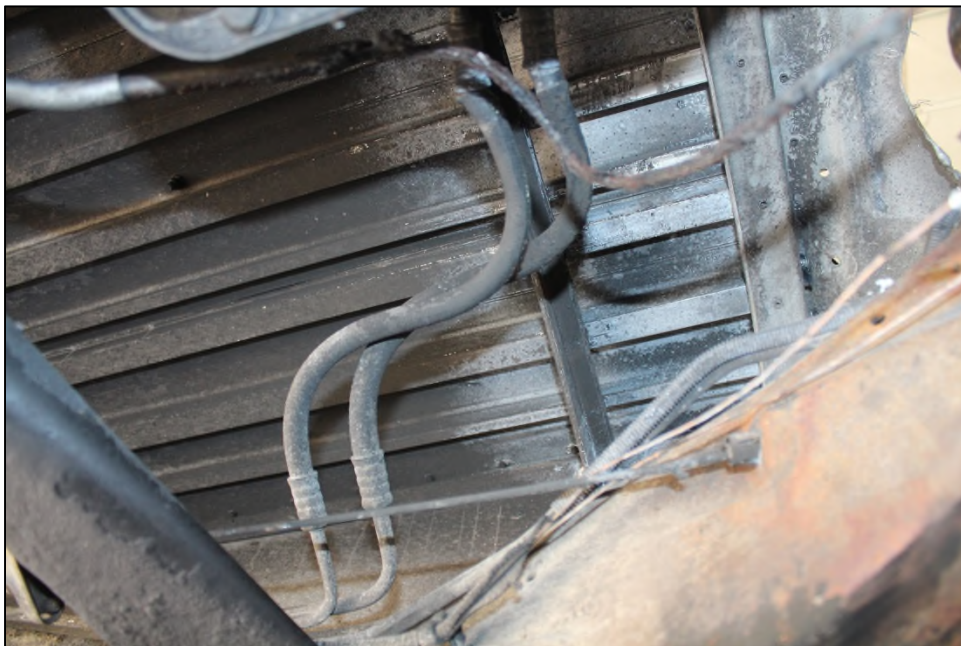
Photograph 10

View of the fuel lines from the undercarriage.

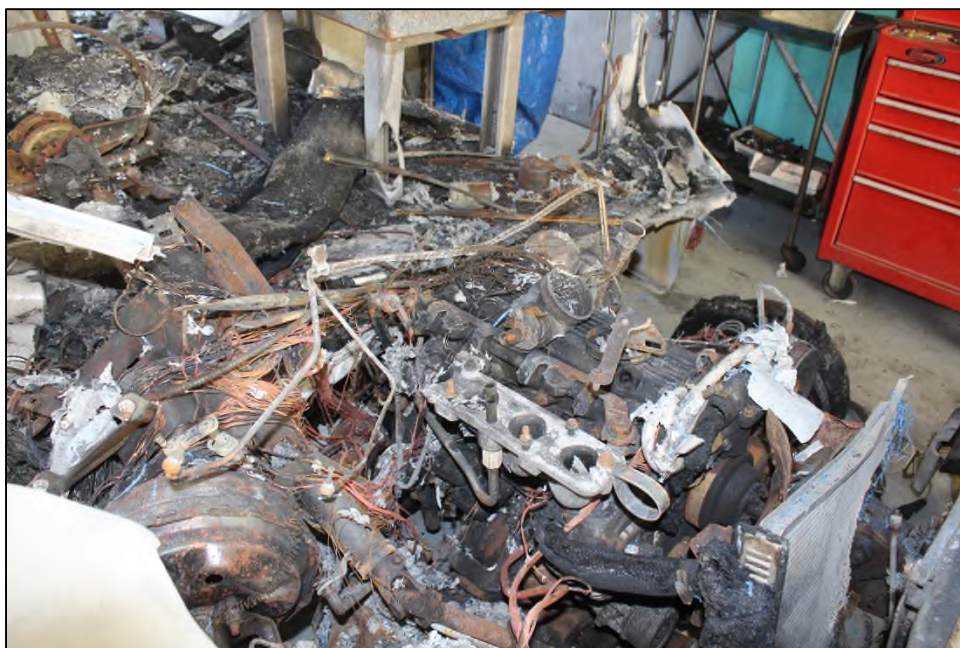
Photograph 11

View of the right side of the engine.

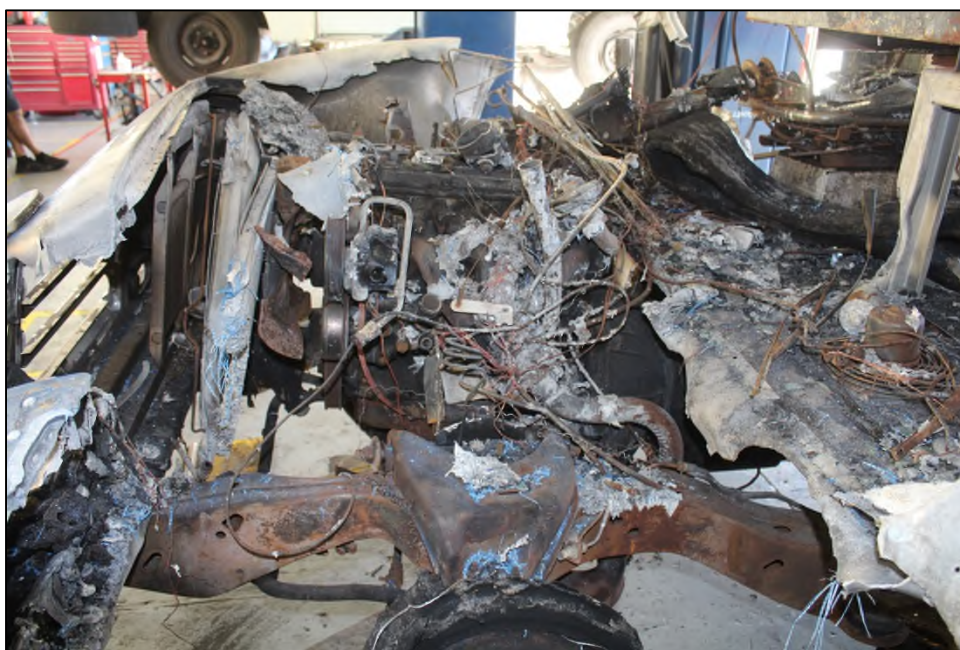
Photograph 12

View of the left side of the engine compartment.

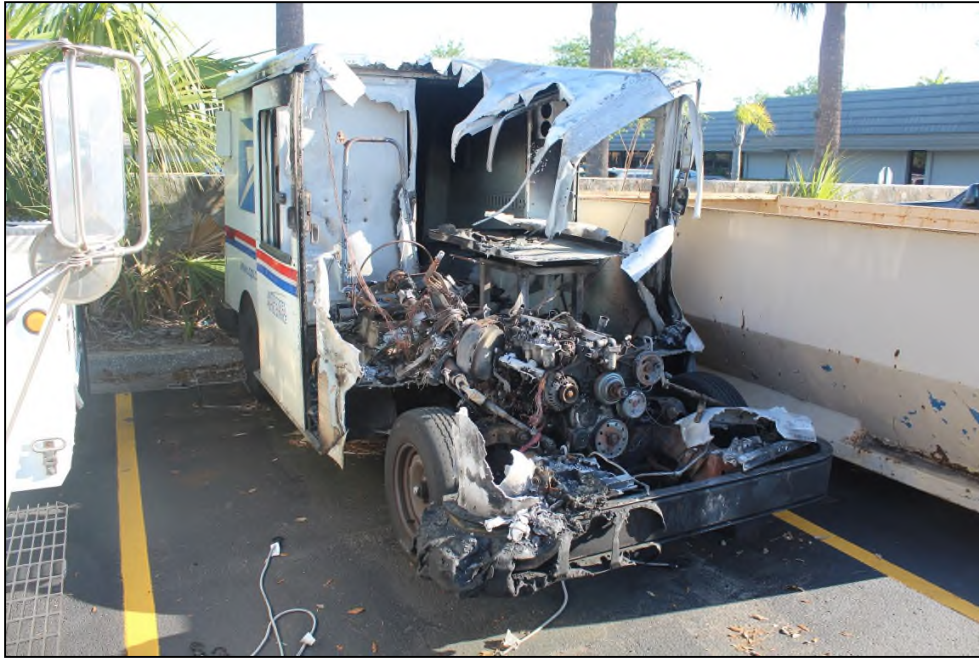
Photograph 1

Overview of loss vehicle.

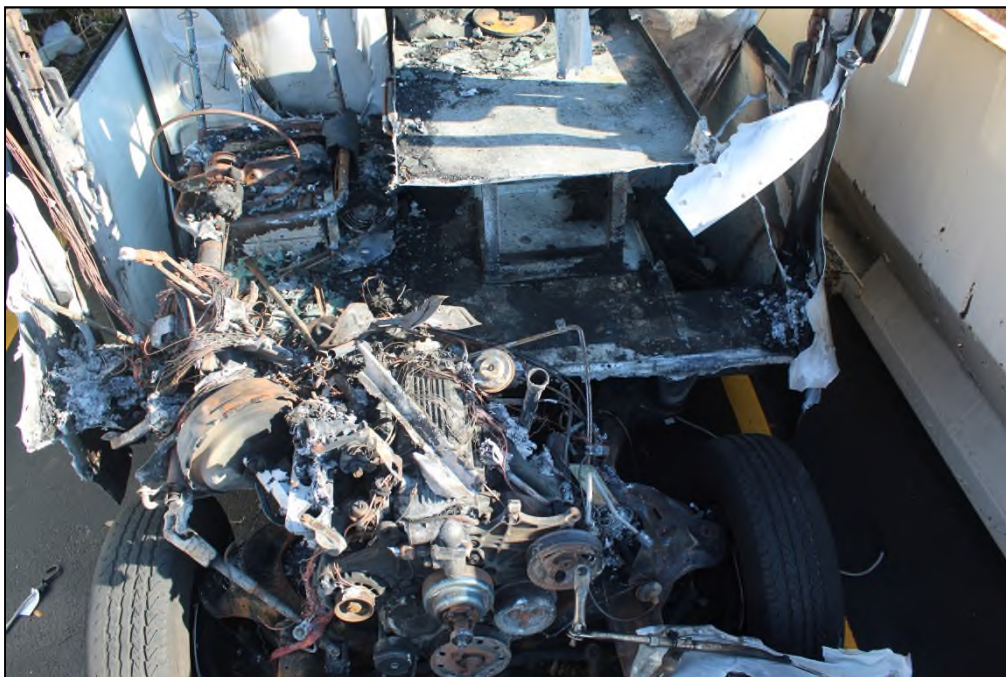
Photograph 2

Damage at engine compartment and cab.

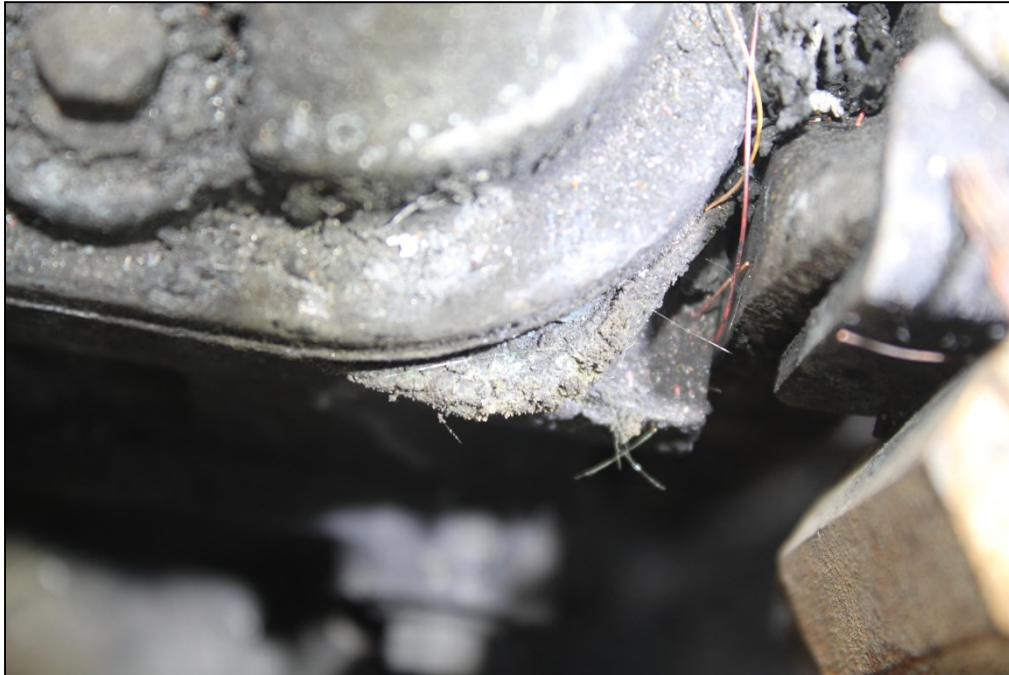
Photograph 3

Unseated gasket at right rear of valve cover.

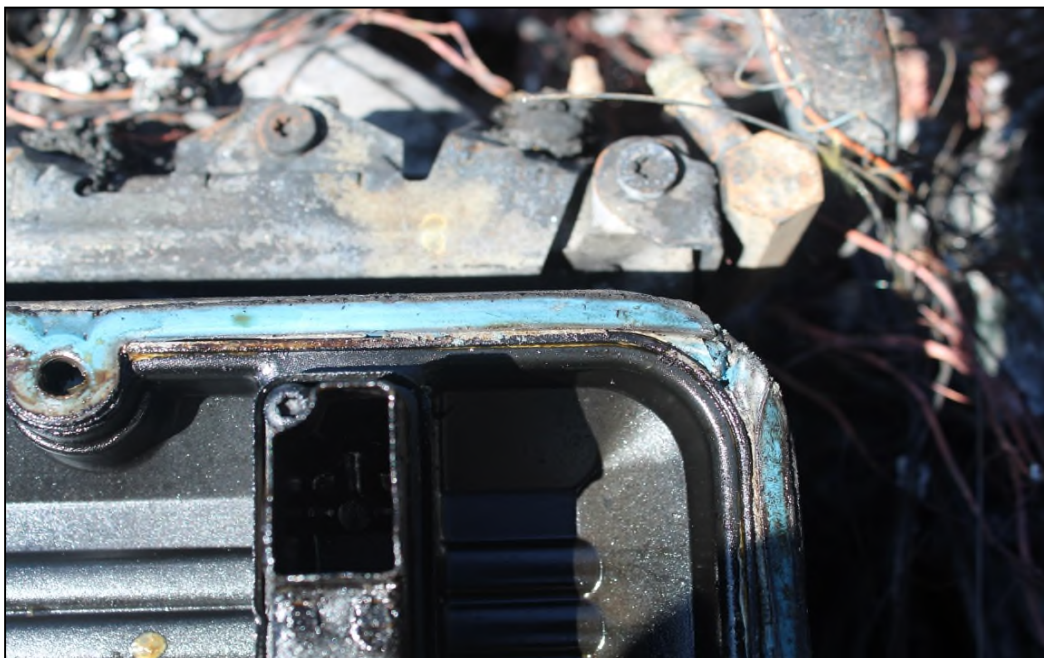
Photograph 4

Unseated gasket at left rear of valve cover.

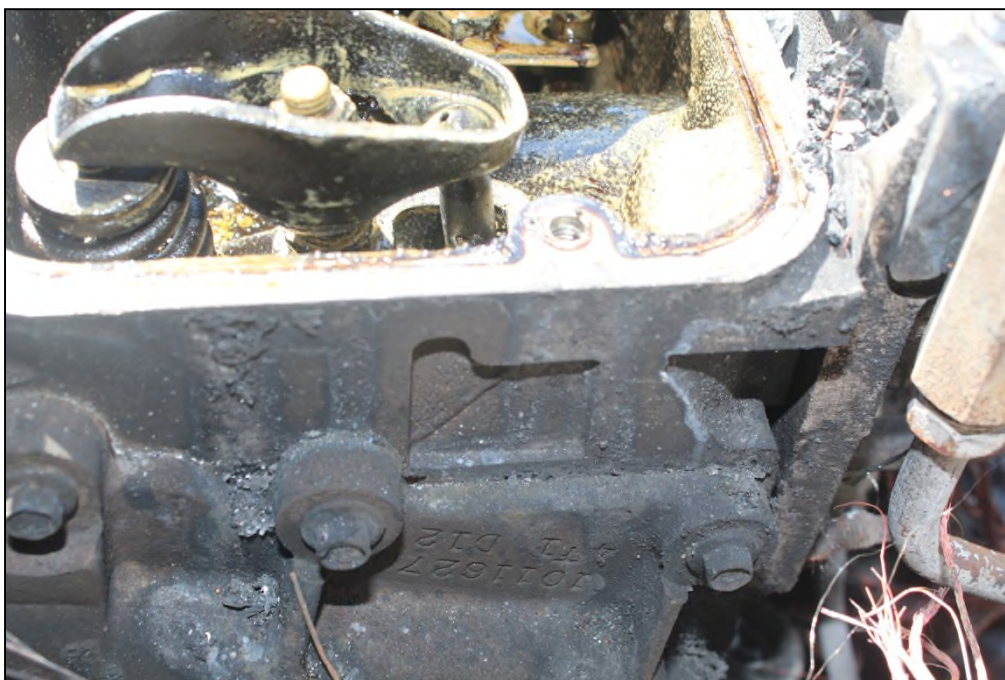
Photograph 5

Rear of cylinder head showing encrusted oil residue.

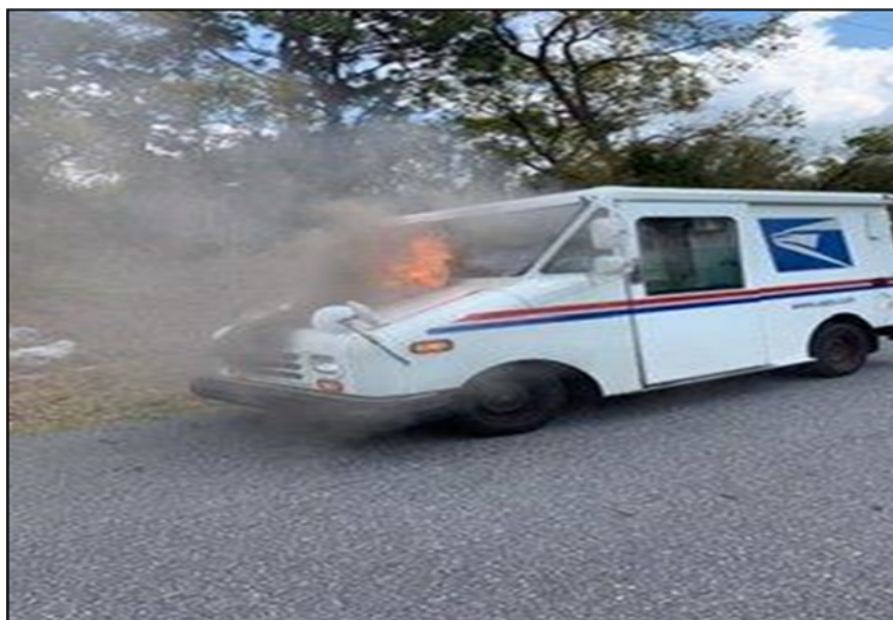
Photograph 6

Bystander photo of early fire development.

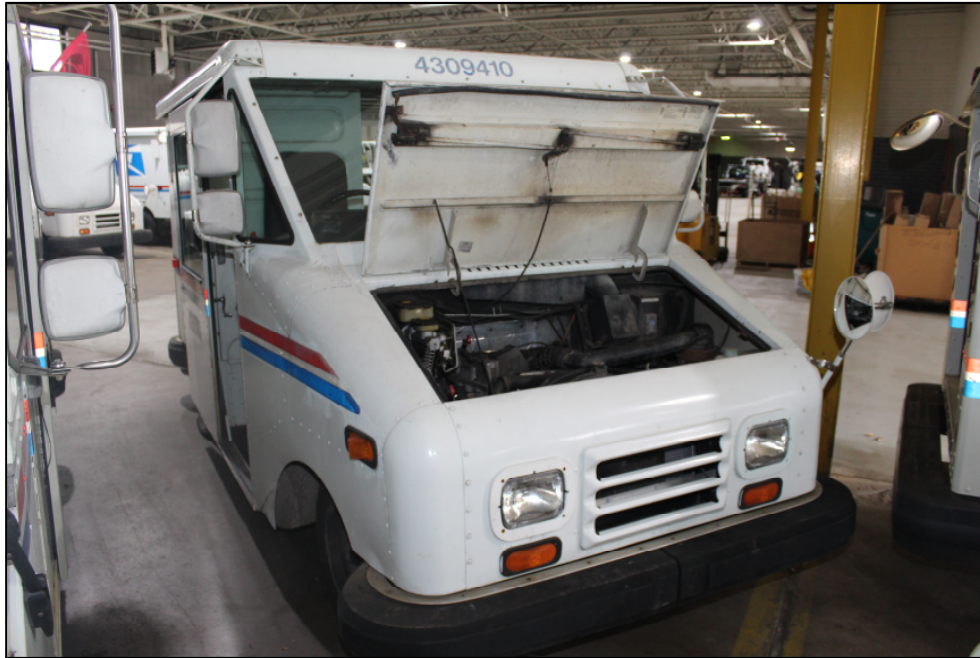
Photograph 1

There was no damage observed to the exterior of the LLV.

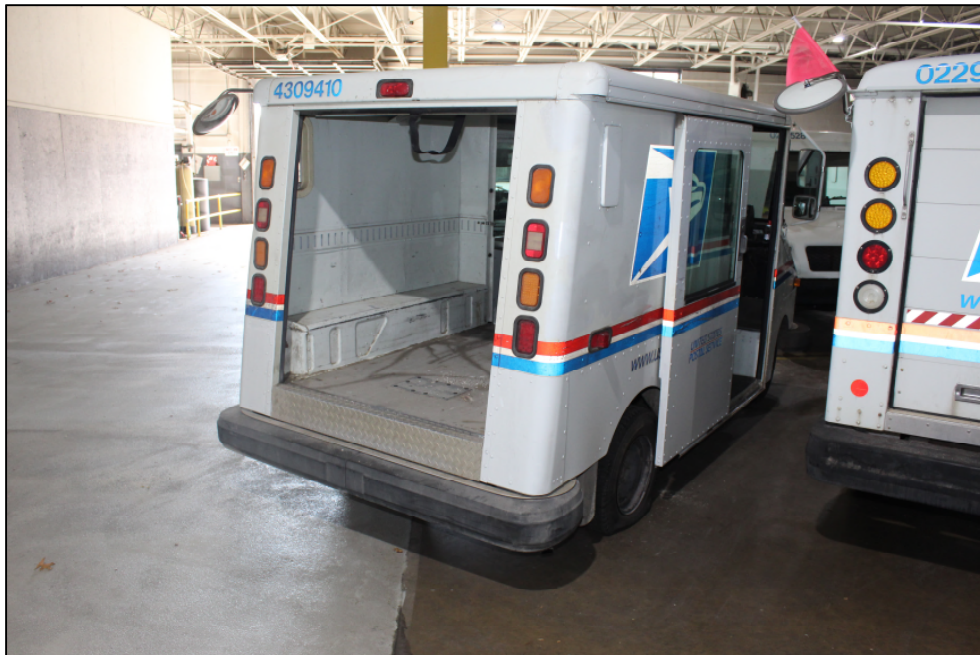
Photograph 2

There was no damage observed to the exterior or interior of the LLV.

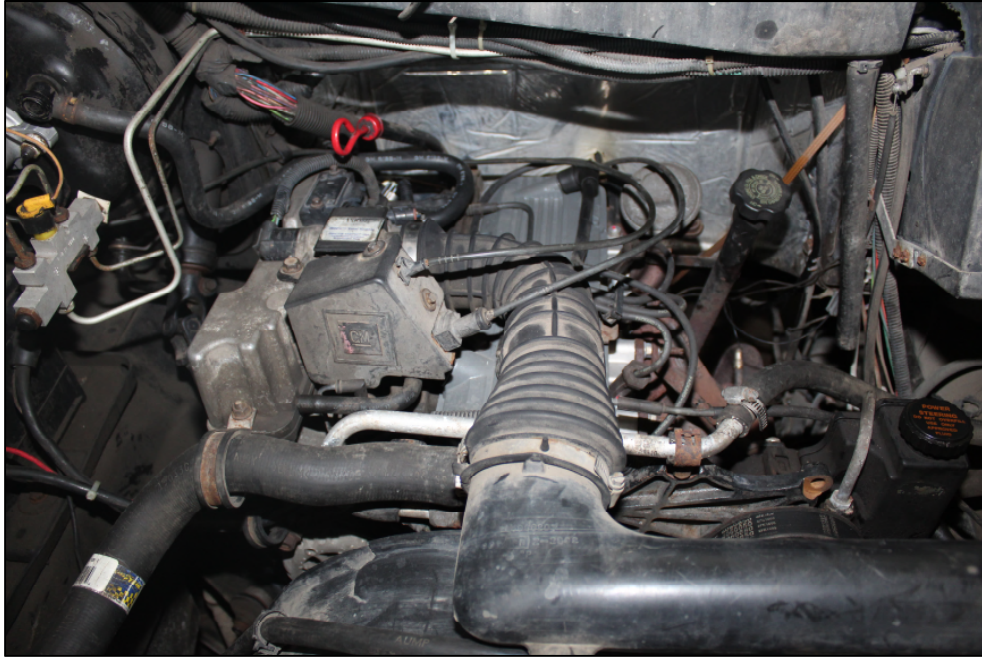
Photograph 3

There was no damage observed to the top section engine compartment of the LLV.

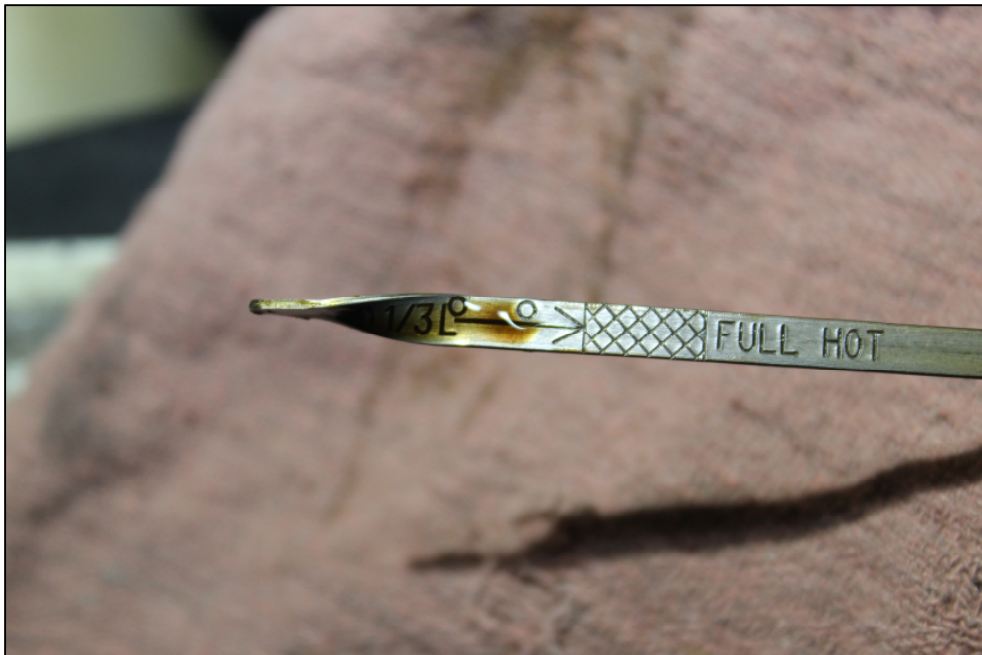
Photograph 4

The transmission fluid level was observed to be very low.

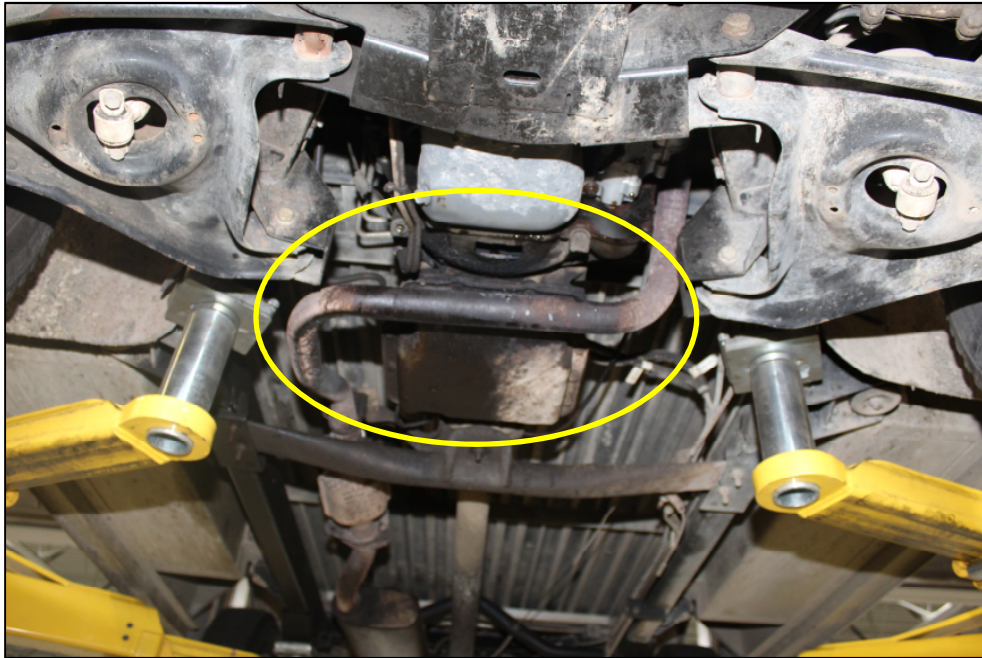
Photograph 5

Area of fire origin was at the exhaust crossover pipe below the transmission.
